MARTINS DAM

PHASE I INSPECTION REPORT
NATIONAL DAM INSPECTION PROGRAM

MARTINS DAM
MONTGOMERY COUNTY, PENNSYLVANIA

NDS I.D. NO. PA 00620
DER I.D. NO. 46-145

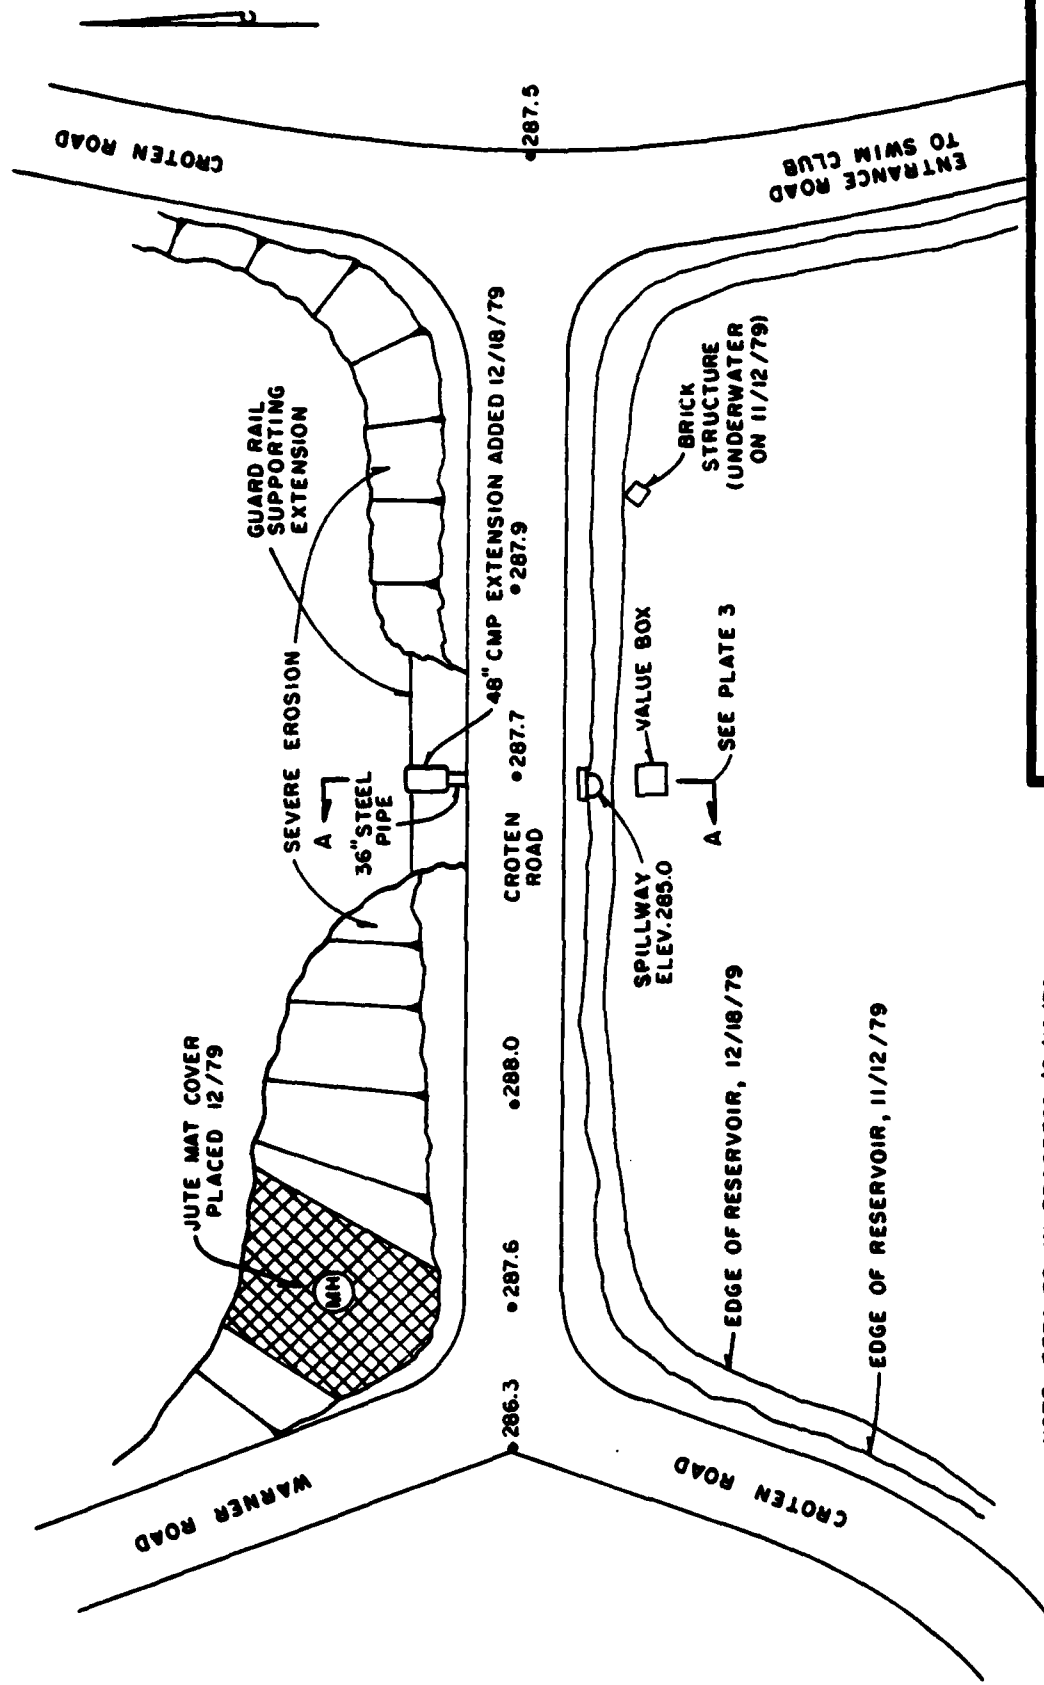
PLATE 2

NOTE: REPAIRS IN PROGRESS 12/18/79

ROADWAY UNDERMINED (REPAIRED BY JANUARY 1980)
